Test Report

No.: SHHL1702007394FT

Sample Description : FERN TASK STOOL CHAIR 3PIC
Sample Receiving Date : FEB. 24, 2017
Testing Period : FEB. 24, 2017 TO APR. 19, 2017
Test Performed : SELECTED TEST(S) AS REQUESTED BY APPLICANT
Test Requested : ANSI/BIFMA X5.1-2017: GENERAL-PURPOSE OFFICE
CHAIR– AMERICAN NATIONAL STANDARD FOR
OFFICE FURNITURE (CLAUSE 5, 6, 7, 8, 9, 10, 11, 14,
15, 18, 19&21)
Test Result(s) : FOR FURTHER DETAILS, PLEASE REFER TO THE
FOLLOWING PAGE(S)
Conclusion : THE SUBMITTED SAMPLE MET THE TEST
REQUIREMENT.

ANSI/BIFMA X5.1-2017: General-Purpose Office Chair– American National Standard For Office Furniture

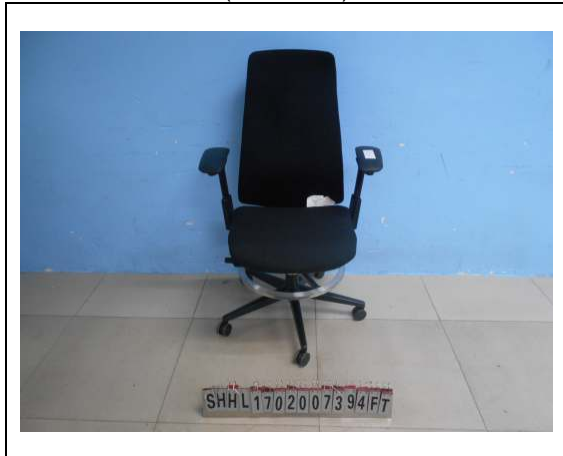
Received sample (NO. 1, 2&3)
(front view)

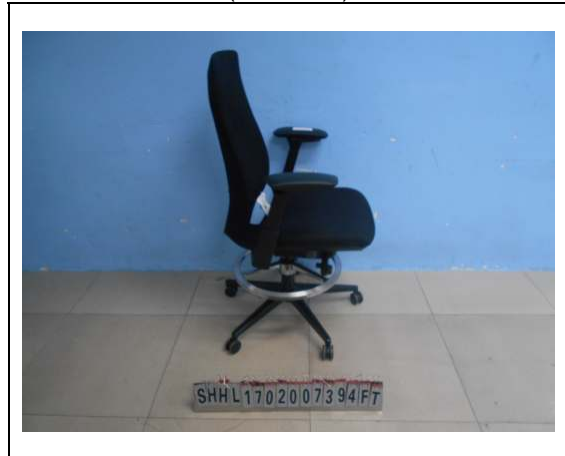
Received sample (NO. 1, 2&3)
(side view)

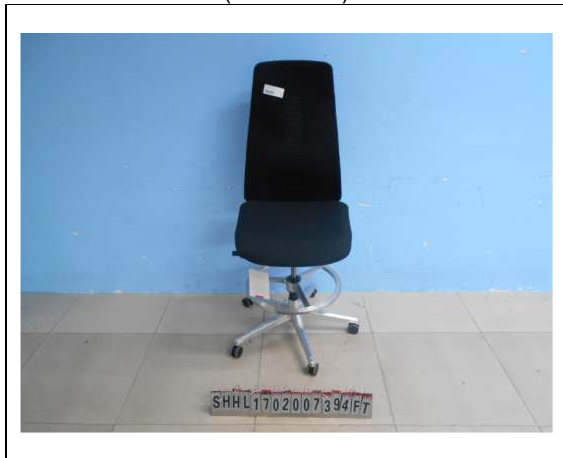
Received sample (NO. 4&5)
(front view)

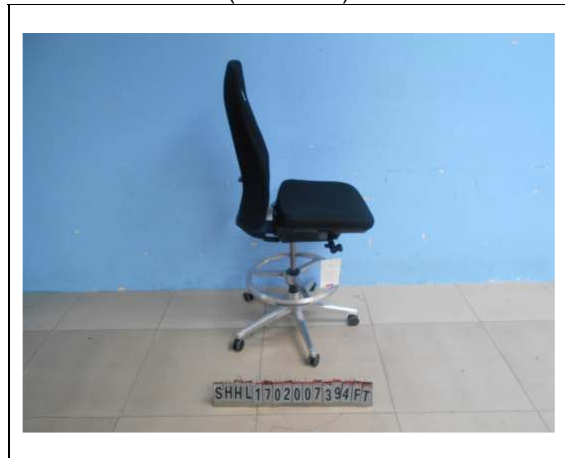
Received sample (NO. 4&5)
(side view)
